**USS TAYLOR (FFG-50)**  
**HULL MECHANICAL ELECTRICAL READINESS**  
**ASSESSMENT**  
**SHELL CONDITION SURVEY**  
**OF INTERIOR AREAS**  
**02/18/03 TO 02/27/03**

**USS TAYLOR (FFG-50)**  
**SHELL CONDITION ASSESSMENT SURVEY, INTERIOR AREAS.**

A HM& ERA UNDERWATER HULL AND SUPPORTING STRUCTURE SURVEY OF INTERIOR AREAS WAS CONDUCTED ON BOARD **USS TAYLOR (FFG-50)** FROM 02/18/03 TO 02/27/03 AT NAVAL STATION MAYPORT, FLORIDA.

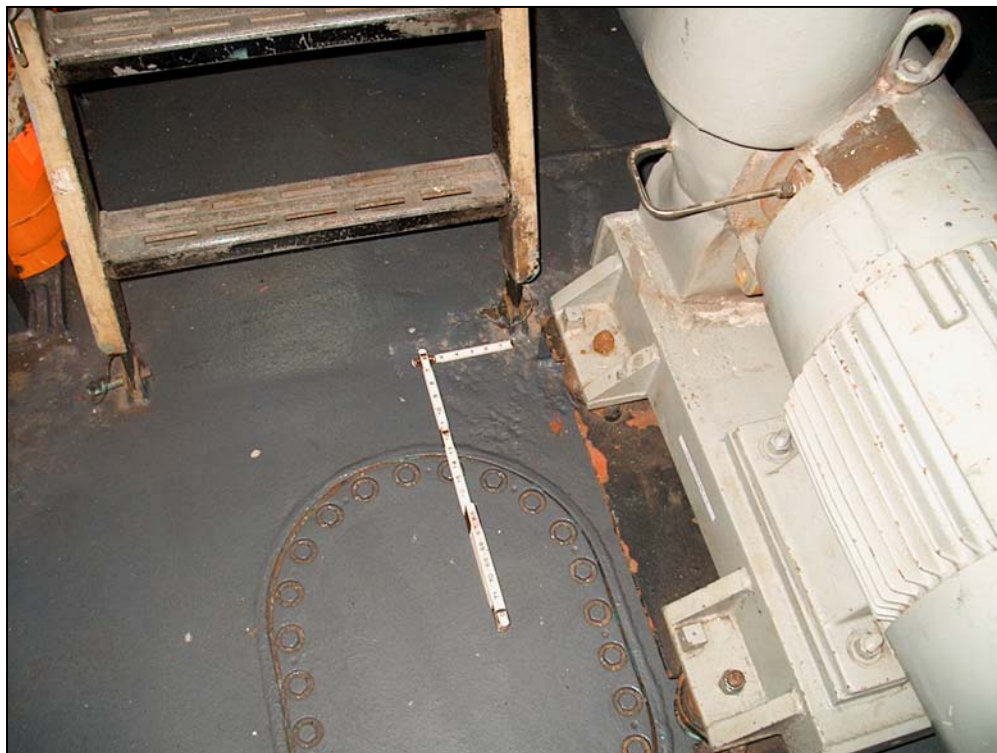
JSN-A404

<b>DISCREPANCY DESCRIPTION: PER HM&amp;ERA UNDERWATER HULL ASSESSMENT: 3-84-0-E A/C MACHINERY ROOM</b>					
DECK WAS ULTRASONICALLY TESTED AS PER CSMP P087. SEVERAL UT READINGS ARE BELOW THE 25% WASTAGE CRITERIA					
HEAVY PITTING IS LOCATED AT THE FOOT OF THE LADDER, AND FROM BHD 100 TO APPROXIMATELY 3 FT FWD, SURROUNDING					
ROUND ACCESS COVER AND RUNNING FORE AND AFT BELOW CHILL WATER PIPE LOCATED APPROX 4 FT PORT OF INBOARD BHD					
.					
<b>RECOMMENDED REPAIRS: GAS FREE AND CLEAN TANK (5-84-2-F), REMOVE CHILL WATER PUMP, FOUNDATION AND PIPING</b>					
INTERFERENCES, LADDER AND DECK CLIPS. CUT OUT DECK FROM BHD 100 TO APPROX. 9 FT FWD AND FROM WELD BUTT					
LOCATED APPROX. 6" TO PORT OF INBOARD BHD TO WELD BUTT APPROX 6FT 6 IN FROM INBOARD BHD. REPLACE WITH .250 OS					
REPLACE ALL INTERFERENCES, LEAK TEST TANK, PRIME AND PAINT.REFER TO NAVSHIPS DWGS. 5534338 REV A & 5534339 REV A					
<b>SSPORT C221 POC: B. WILLIAMS (757-396-4001 EXT-2166 ) TPOC: C. BUCK</b>

DEEP PITTING OF THE TANK TOP/ DECK AT THE FOOT OF THE LADDER

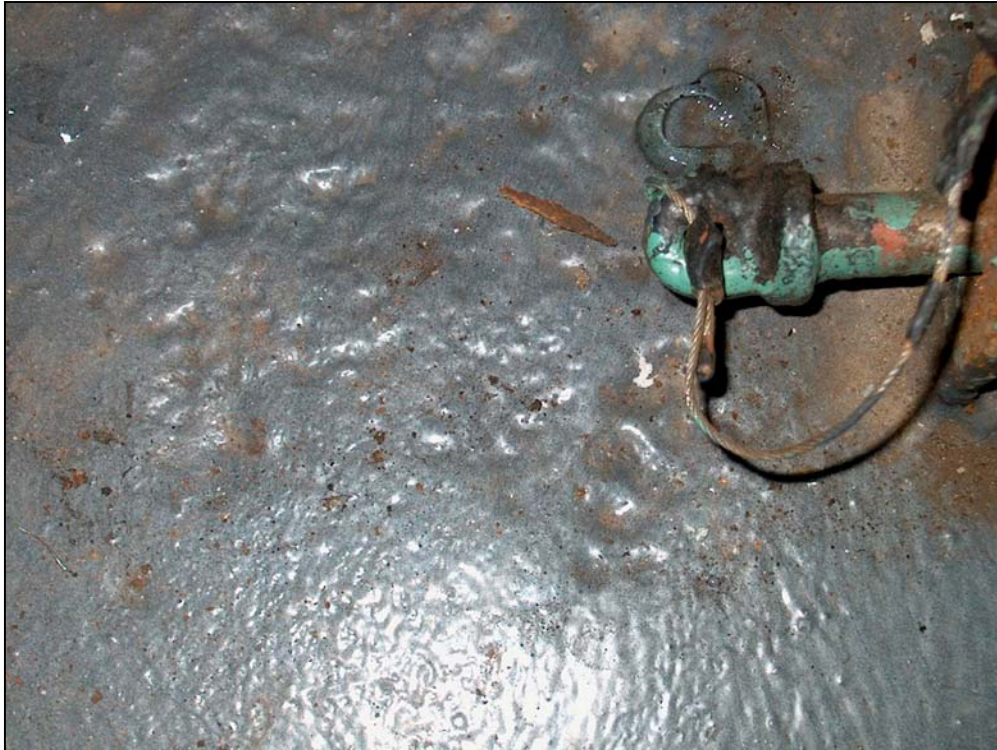
PITTING OF THE DECK, STARBOARD LEG OF THE LADDER. JSN A404

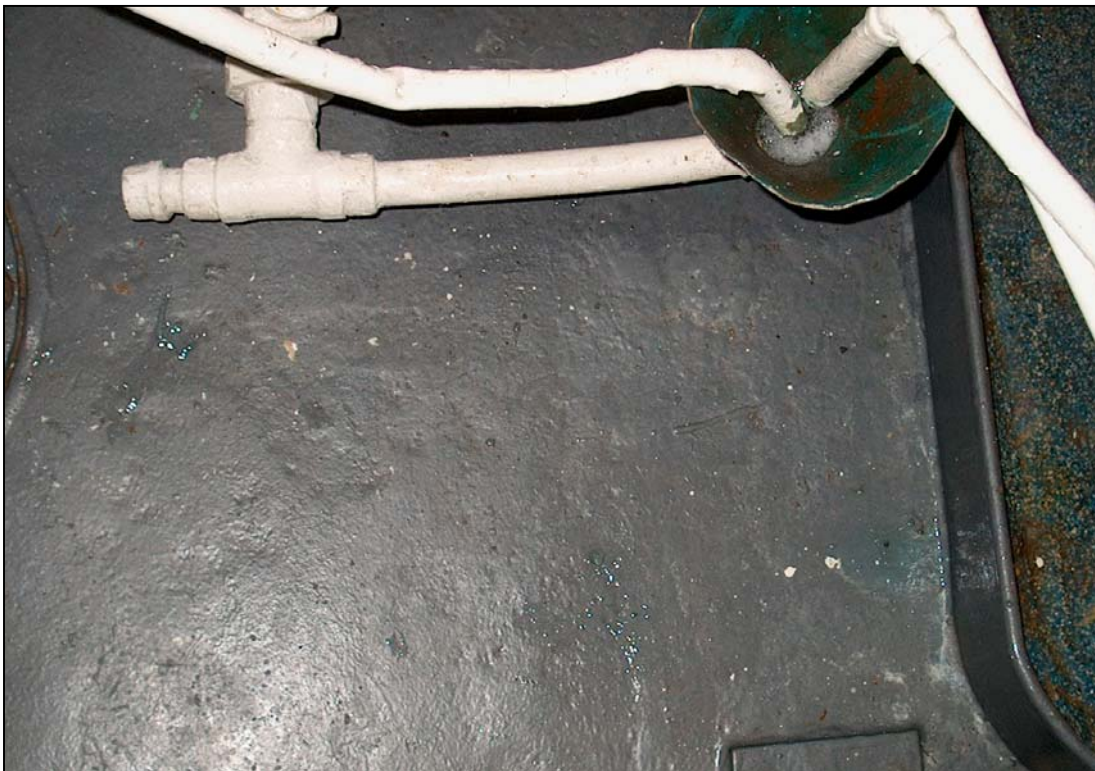
PITTING, INBOARD OF A/C UNIT. JSN A404
